# Veraflo™ Therapy

## 3M™ Veraflo™ Therapy

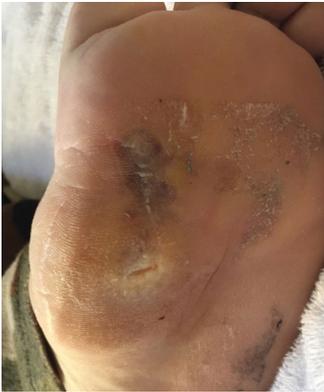
**Figure 1.** Diabetic foot abscess upon admission.

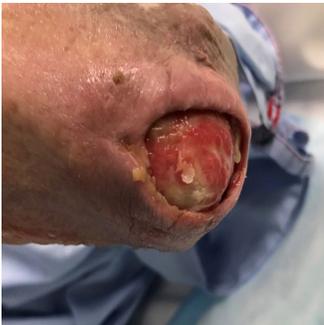
Figure 1. Wound at presentation.

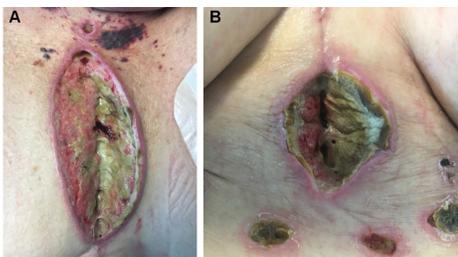
**Figure 1.** Wounds at presentation. Sternal (A) and midline (B) wounds are shown.

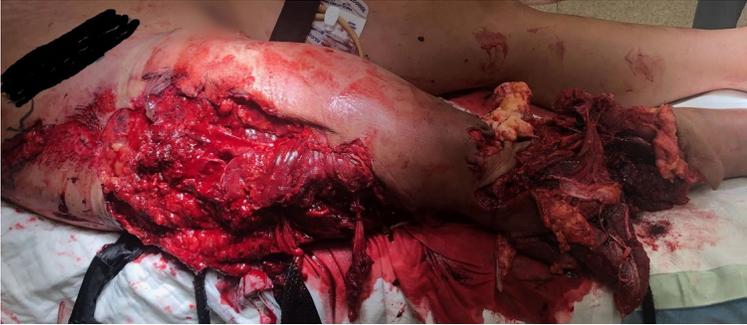
**Figure 1.** Extensively injured right leg at initial presentation.

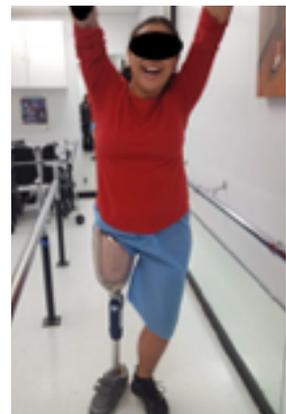
**Figure 8.** Patient 167 days after initial injury, taking first steps on a new prosthesis.
