# 3M™ Dermatac™ Drape with 3M™ V.A.C.® Therapy case studies

## **Introduction**

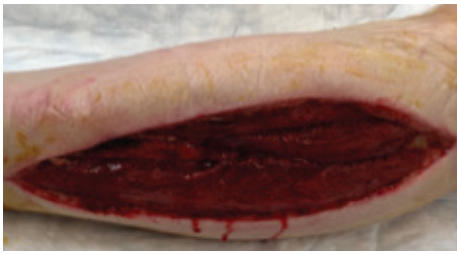
**Figure 1.** Left lateral calf at presentation (20cm x 12cm x 0.1cm).

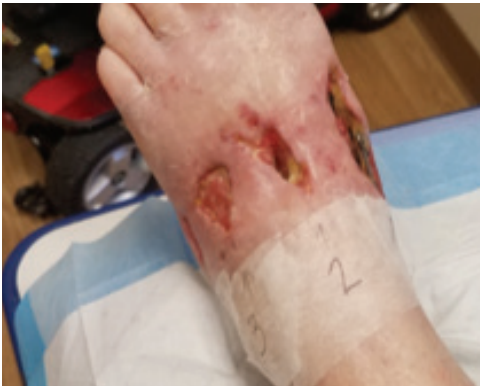
**Figure 1.** Dehiscent wounds after debridement, 1 week of 3M™ Veraflo™ Therapy with standard drape, and 1 week of 3M™ V.A.C.® Therapy with 3M™ Dermatac Drape.
