S solventum

Case studies

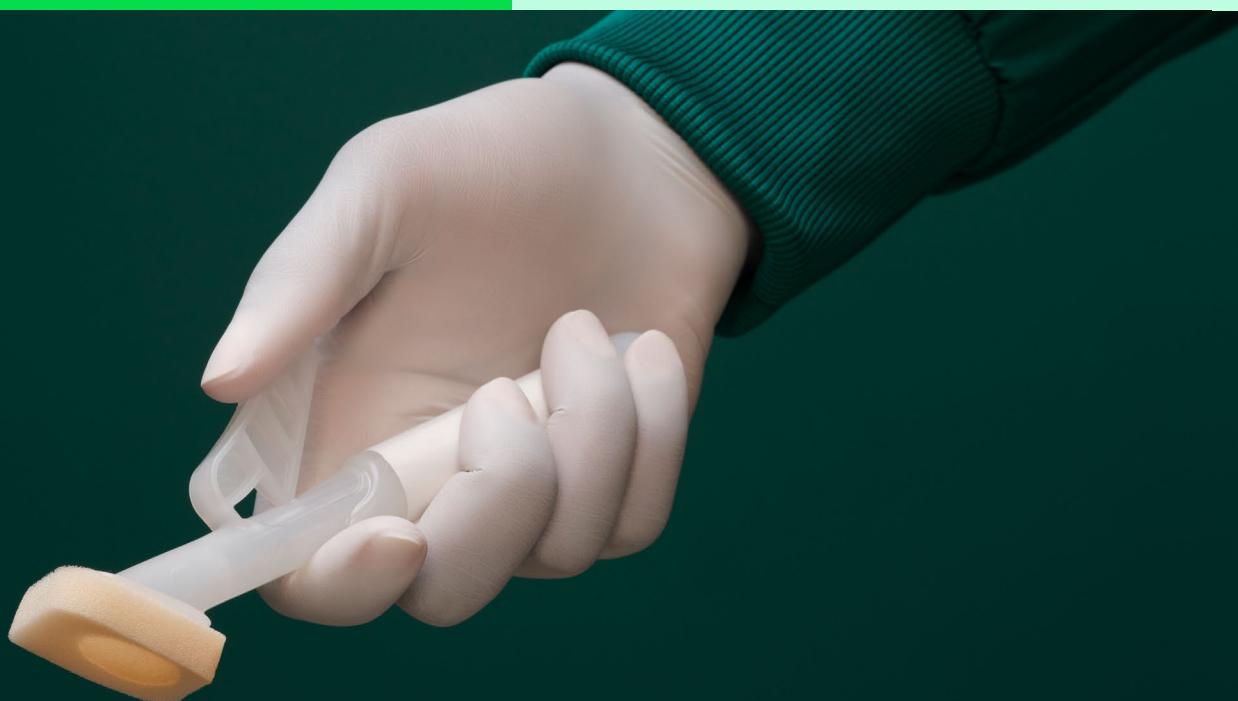
3M™ Cavilon™ Advanced Skin Protectant combines a unique polymer system with a cyanoacrylate to create a highly durable, ultra-thin, transparent barrier with elastomeric properties

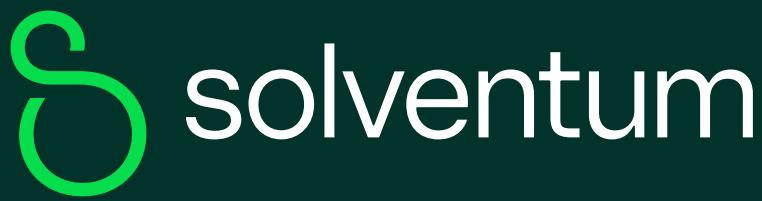
Solventum Medical Surgical
3M Center, Building 275
2519 Conway Avenue East
St. Paul, MN 55144-1000
